## **Manufacturing Notice**

Name:	<b>Plating New Installation Rims</b>
-------	--------------------------------------

Affected Parts:	<b>All two piece "New Installation" Custom Cupholder Company top appearance rims.</b>
Part Name:	<b>Top Appearance Rim</b>

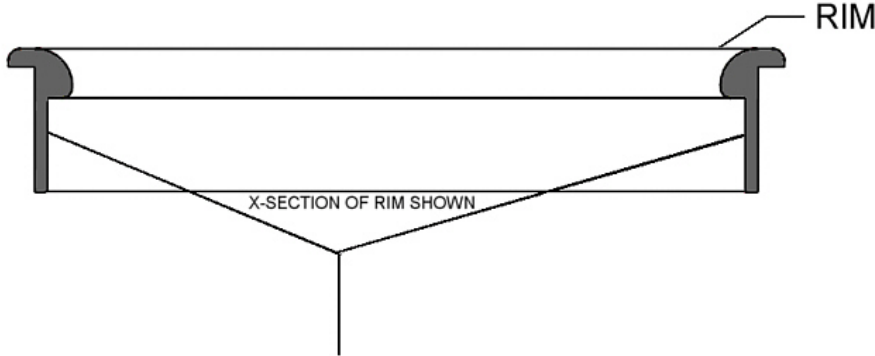
<p style="text-align: center;">X-SECTION OF RIM SHOWN</p> <p style="text-align: center;">RIM</p> <p>MAXIMUM PLATING THICKNESS ON INSIDE OF RIM FLANGE TO BE NO MORE THAN .004". REMOVE ANY LOCALIZED BUILDUP OR POOLING OF PLATING FINISH.</p>
---------	--

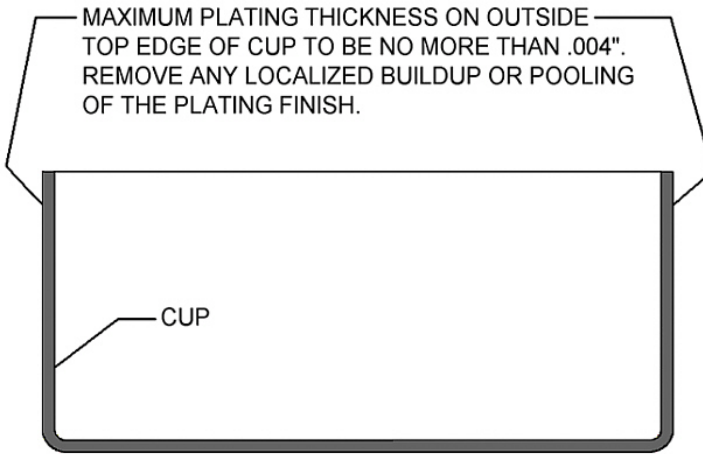
Notice:	<p style="text-align: center;"><b><u>IMPORTANT PLATING INFORMATION</u></b></p> <p style="text-align: center;">MAXIMUM PLATING THICKNESS ON OUTSIDE TOP EDGE OF CUP TO BE NO MORE THAN .004". REMOVE ANY LOCALIZED BUILDUP OR POOLING OF THE PLATING FINISH.</p>

<p style="text-align: center;">X-SECTION OF CUP SHOWN</p>
---------	--
